EXPERIMENTAL INSTALLATION OF LARGE DIAMETER (48 in.) HIGH DENSITY POLYETHELENE CULVERT PIPE (HDPE)

CONSTRUCTION REPORT

SEPTEMBER 2000

CONSTRUCTION REPORT
Report # PE-09-00

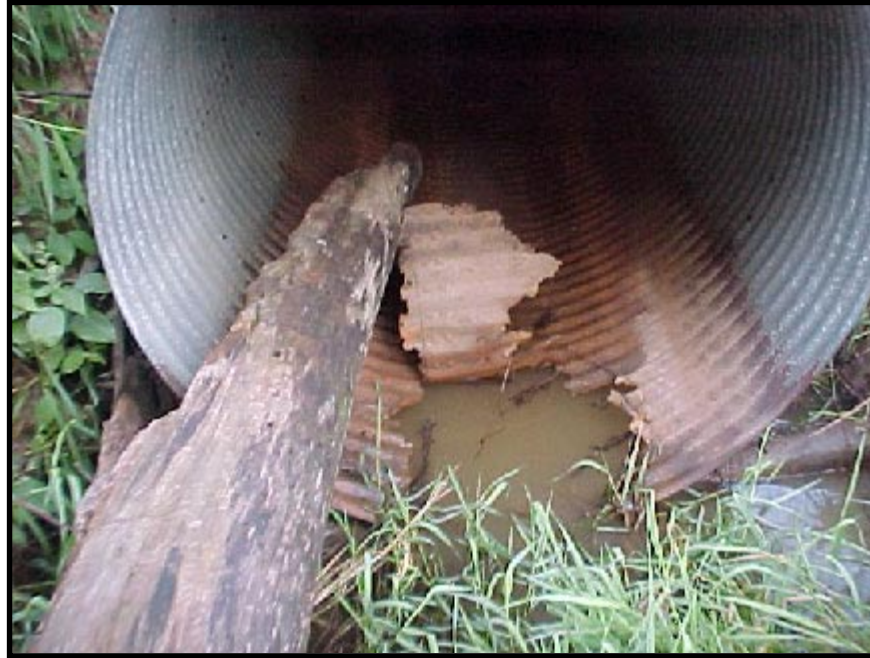
Upon removal of the existing 54 in. corrugated metal pipe (Prints 1-7, Appendix C), it was observed that the bottom of the pipe was deteriorated and corroded, probably due to standing acidic water in the bottom of the pipe. It was estimated that the pipe was approximately 25 years old.

Print 1. View of the inlet of the old metal corrugated culvert pipe. Notice the deterioration of the pipe on the bottom due to the acidic water.

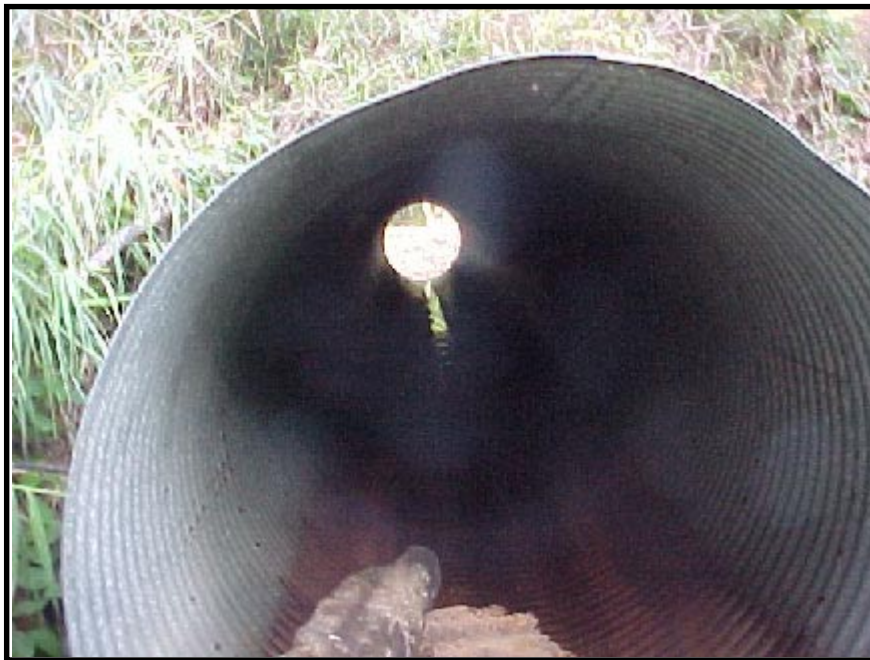
Print 2. Another view looking at the old pipe from the inlet end.

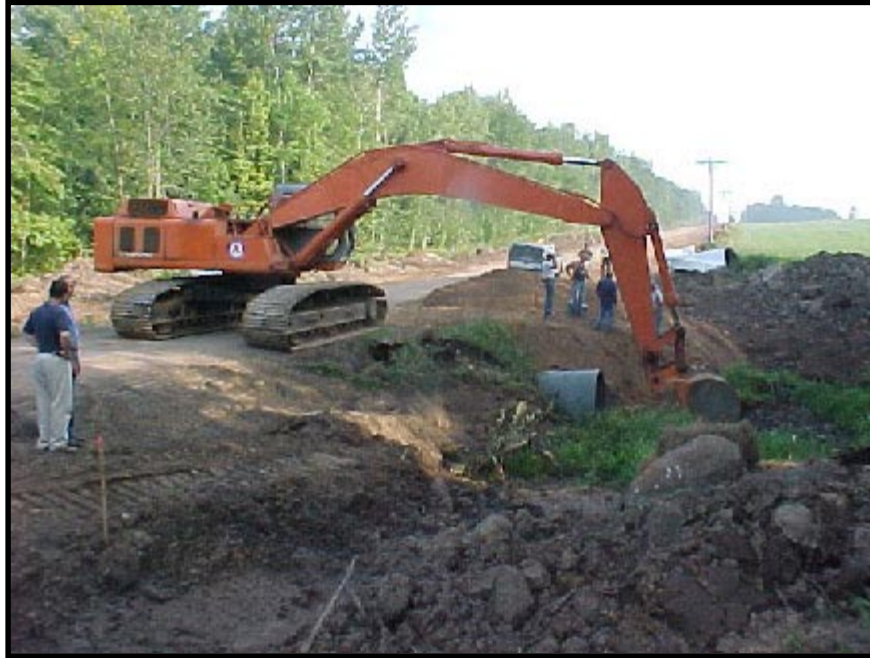
Print 3. View of the old pipe prior to removal.

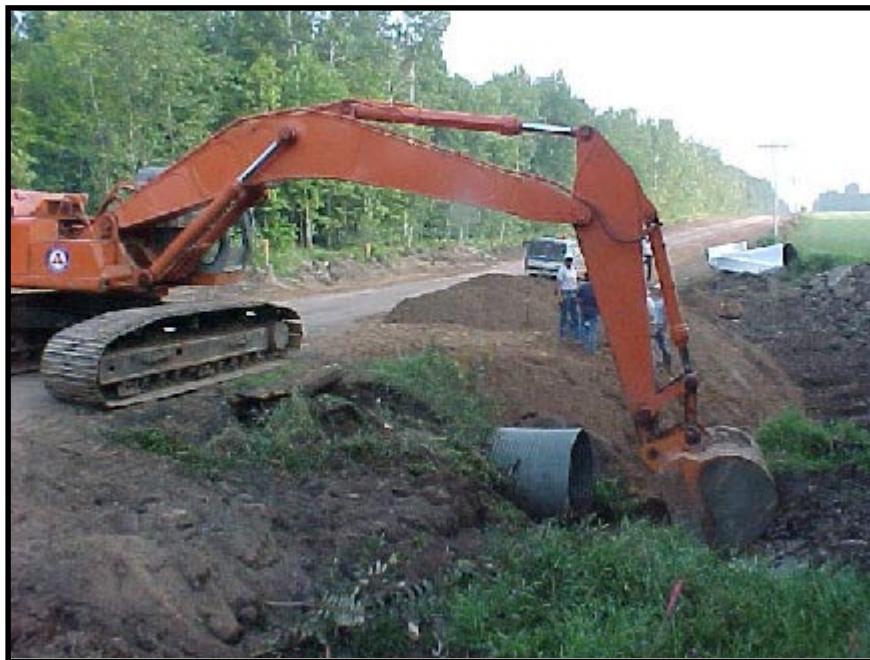
Print 4. A closer view of the same image above.

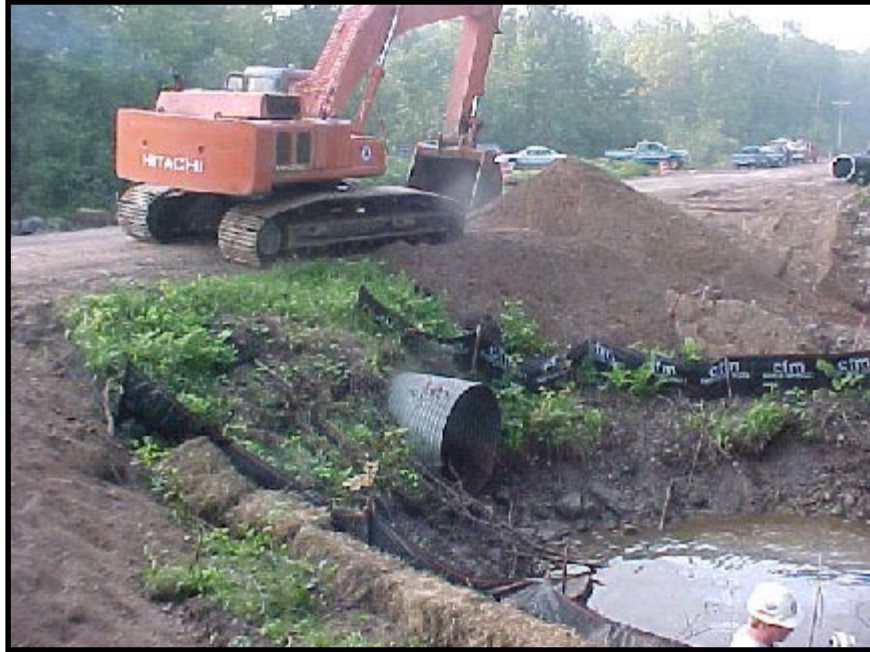
It was learned that a recent 12 in. rainfall in the area had flooded the roadway and water was flowing over the road. The storm had lodged a large tree trunk approximately 10 feet long and 18 in. in diameter at the old pipe inlet indicating significant flow during storm events.

Print 7. View of the outlet and scour hole of the old pipe. Most of the water was pumped out of the scour hole prior to the removal operation.

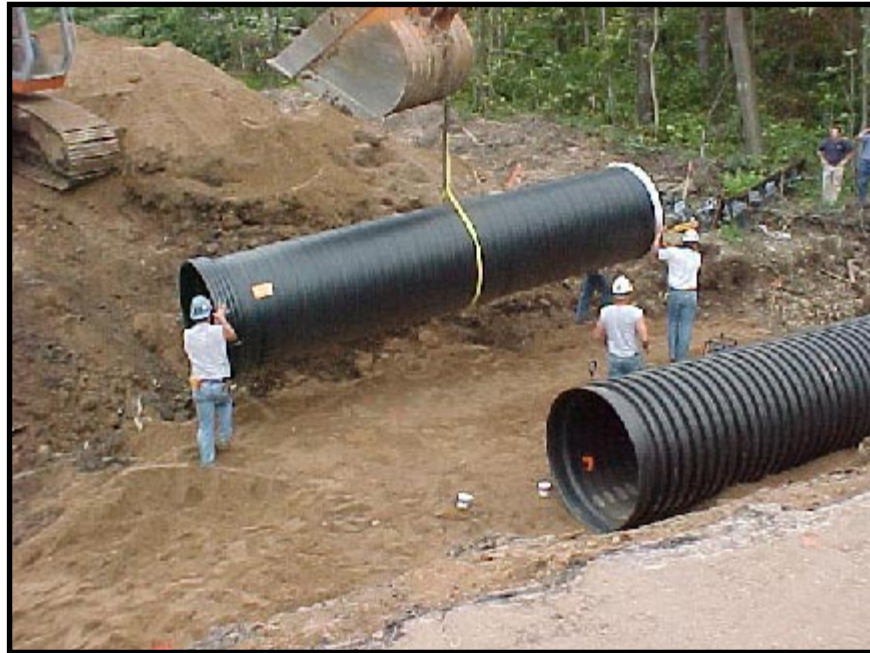
A concern of the ADS pipe related to its construction: this pipe needs to be ordered in exact lengths as it cannot be cut in the field due to the nature of its construction. A cross-section of the pipe has hollow “channels” that could allow water to flow through the shell of the pipe itself. In addition, the end of the pipe does not have corrugations to attach the end wall aprons securely. This may result in rotation of the apron endwalls. As previously mentioned, the ADS pipe was not corrugated on the outside. It is unknown whether or not this will present a stability problem with large flows, i.e. will the pipe stay in place without the corrugated exterior helping to “hold” the pipe in place due to increased friction.

Print 9. Placing the ADS pipe on the bedding material, Hancor pipe is on the right. Notice the ADS pipe has a smooth exterior with no corrugation.

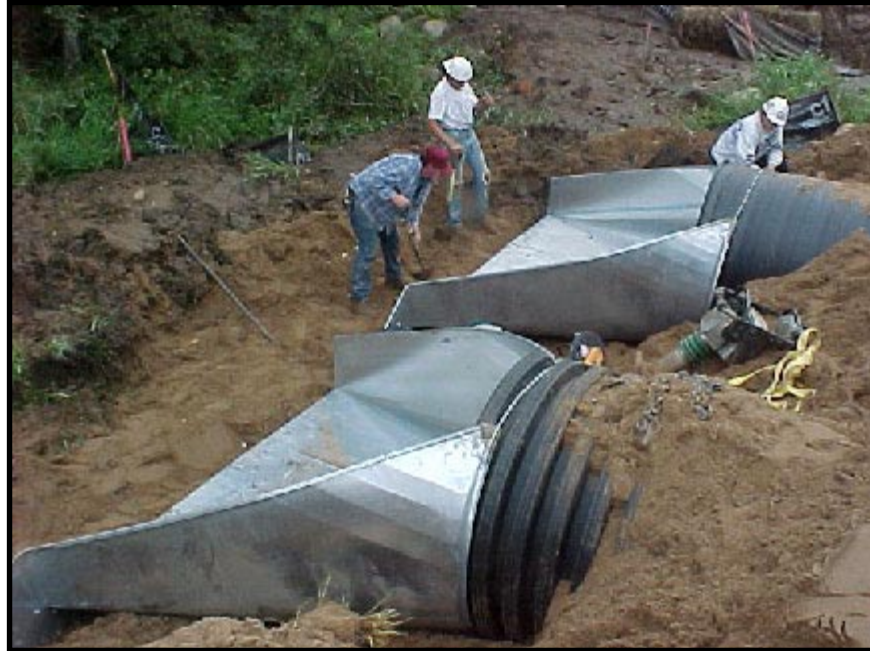
Print 17. Another view of the end wall aprons. Notice the lip or groove on the Hancor pipe in the foreground providing sound attachment of the end wall apron to the culvert pipe.

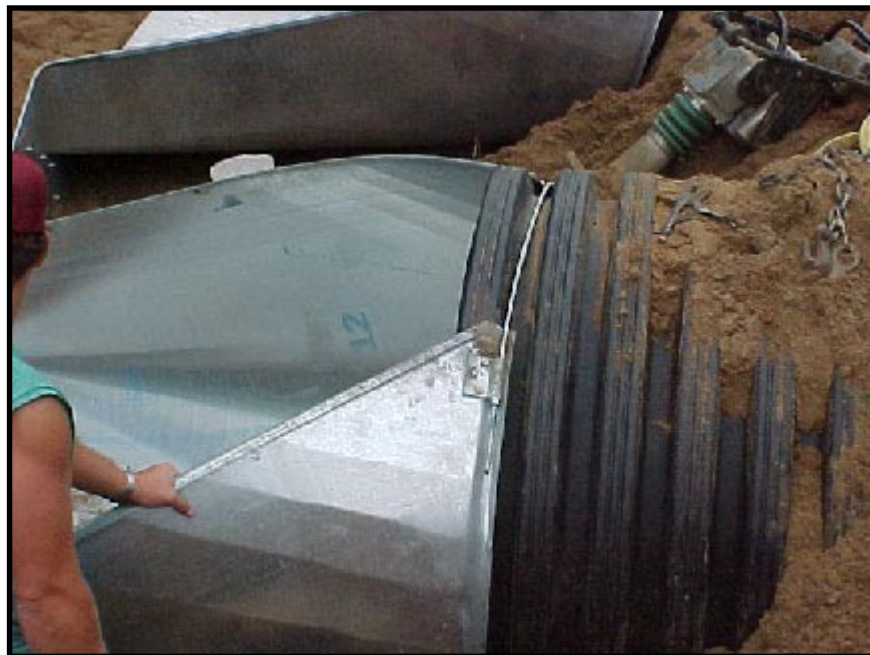
Print 18. A close up view of the end wall apron attachment to the Hancor pipe.

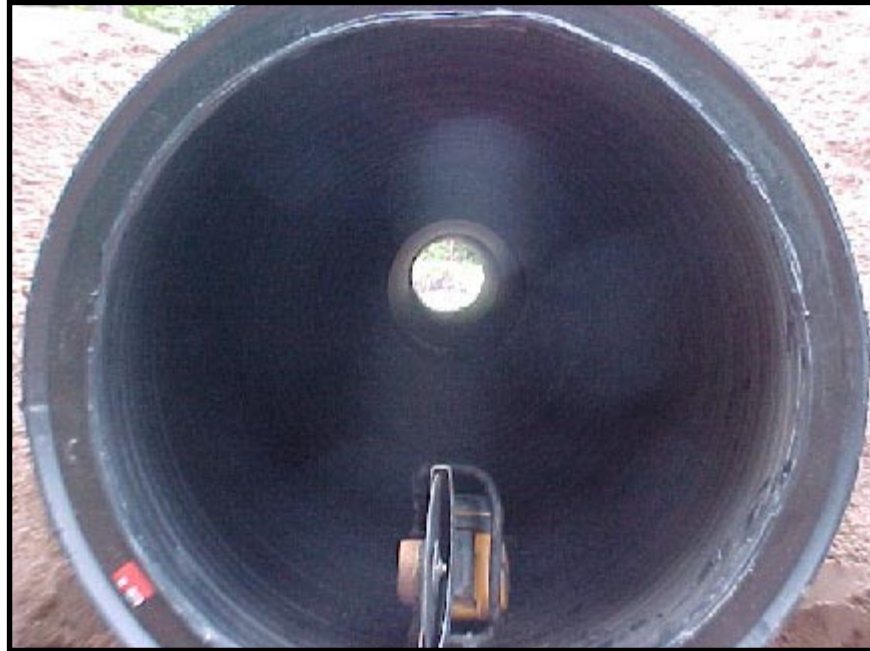
Print 19. View of the ADS pipe after installation showing no noticeable deformation from the installation.

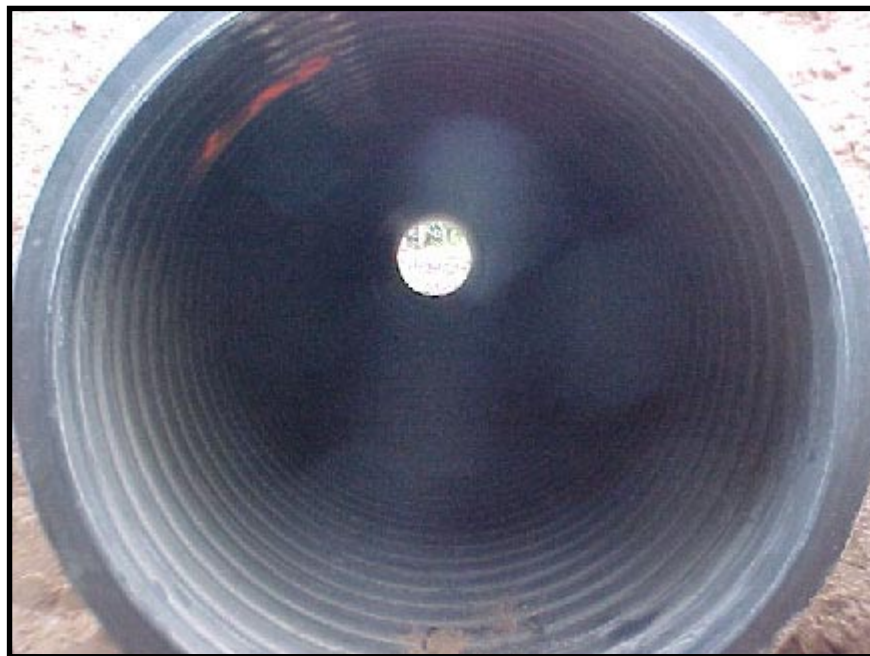
Print 20. View of the Hancor pipe after installation showing no noticeable deformation from the installation.
